**Urban Mass
Transportation
Administration**

Field Testing of Electronic Registering Fareboxes

UMTA-MA-06-0120-86-2
DOT-TSC-UMTA-86-9

February 1987
Final Report

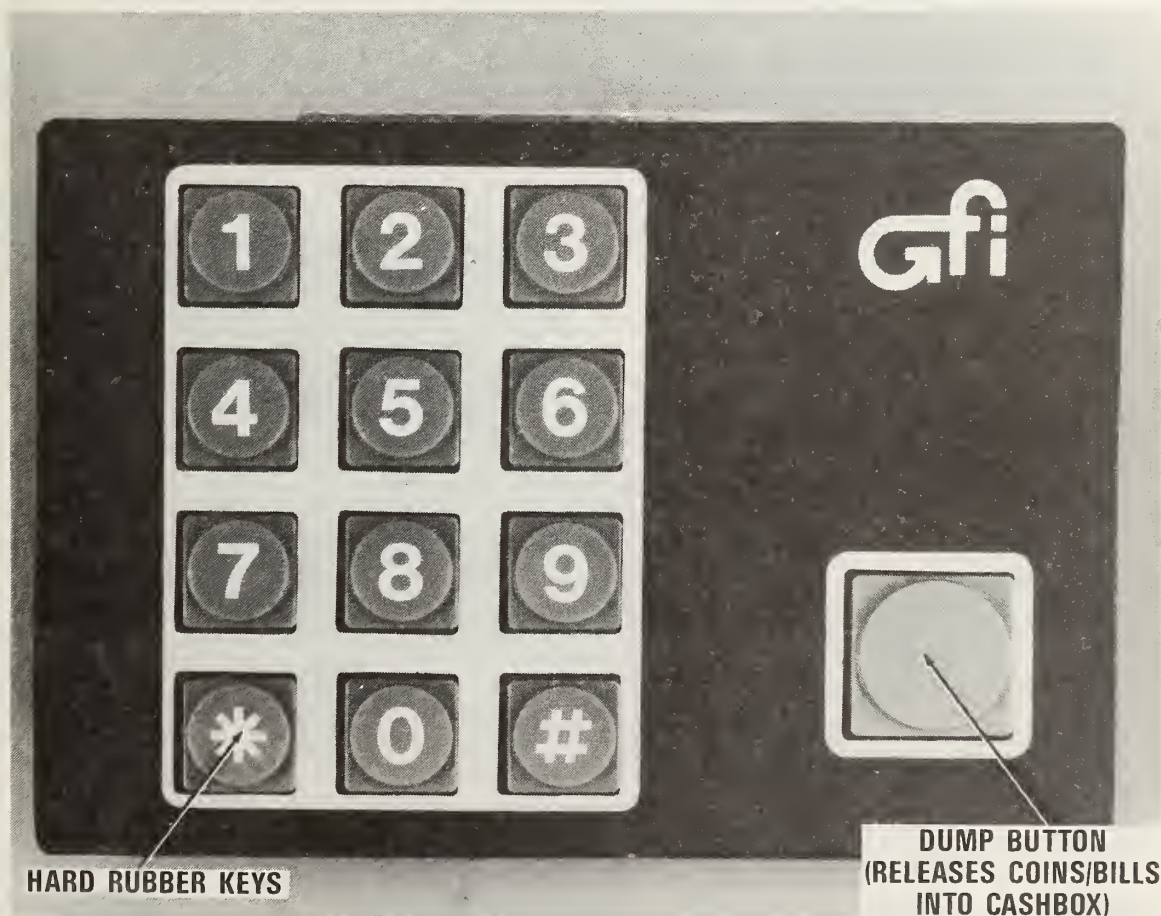
FIGURE 4-4. IMPROVED KEYPAD

- Keypad. The keypad experienced extreme rapid wear from the outset of the test due to the operators' fingernails gouging the soft plastic keys. A new keypad design with hard rubber keys, shown in Figure 4-4, was substituted by GFI in May. No further problems with wear of the keypad have been experienced.

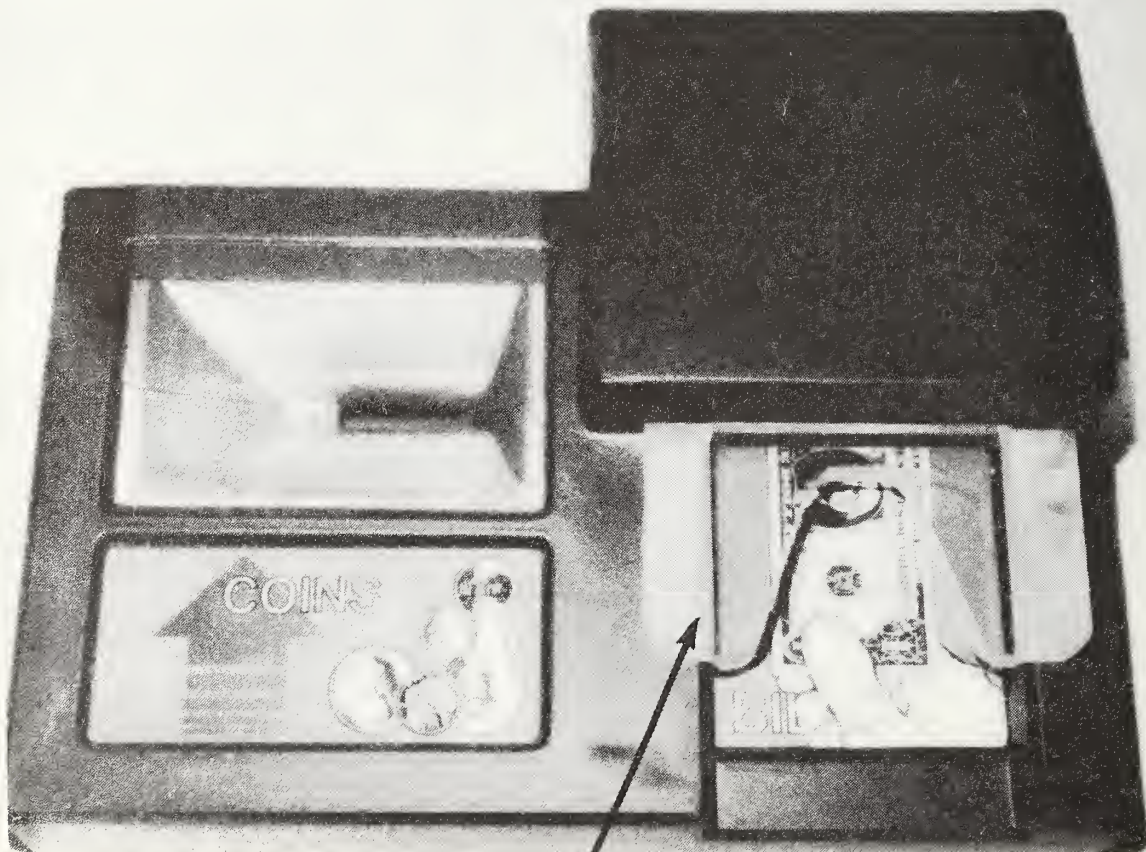
FIGURE 4-5. PLASTIC TICKET INSERTION GUIDES

- . Bill Insert. GFI installed plastic ticket insertion guides on the farebox to keep the tickets properly aligned in the bill transport. However, the ticket guide blocked proper insertion of dollar bills, and passengers removed the guides to insert the bills. The problem of tickets occasionally becoming misaligned on the bill transport still occurs. The plastic ticket guides are shown in Figure 4-5.

TICKET INSERTION
GUIDE
